# SURVEY FORM

The Quincy Preservation Commission, Quincy, Illinois

808 North Sixth Street

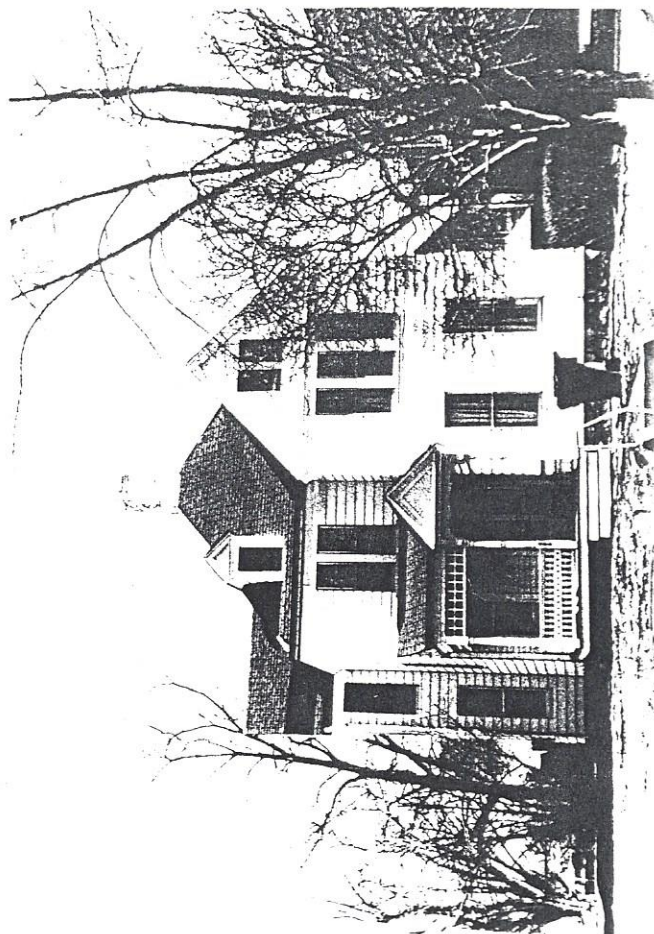
Nearly identical to 617 Elm Street, just around the corner. 2-1/2 stories. irregular plan. random limestone foundation with "vining" (raised) mortar. artificial siding (wide white). gabled pyramidal hip roof (asphalt shingle). entrance porch left of right/south gable front pavilion extending out from small reentrant angle with steep pediment over entrance bay; starburst in pediment with scalloped cornice with incised scroll design. stylized balustrade with slat and cut-out circle patterned, turned posts; sunburst in side of shed too. 1/1 double hung sash; no surrounds with artificial siding. 2nd story sash in pairs and sets. paired fixed sash at attic in gables. leaded stained glass upper sash of 1/1 to left/north of entrance. double door entrance with transom. small gable roof dormer off-set over entrance bay front; large fixed sash. north gable wing one bay wide from front/west. 2 story gable semi-hexagonal bay south. huge central brick chimney. rear 1-1/2 story gable wing.

Under restoration by current owner who reports the artificial siding is to be removed!

Condition: ☐ Excellent ☒ Good ☐ Fair ☐ Deteriorated

Wall treatment.
