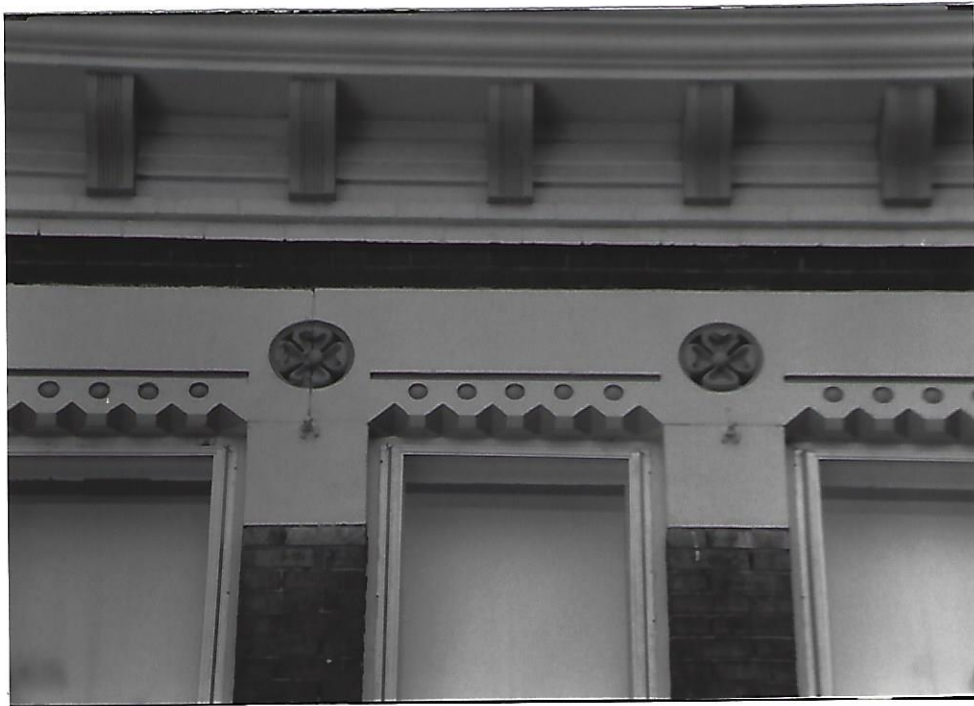
Detail of the second story window headers on the West facade—Shows the rosettes, scalloping and bead carvings in the stone; also shows the carved wood brackets at the roofline

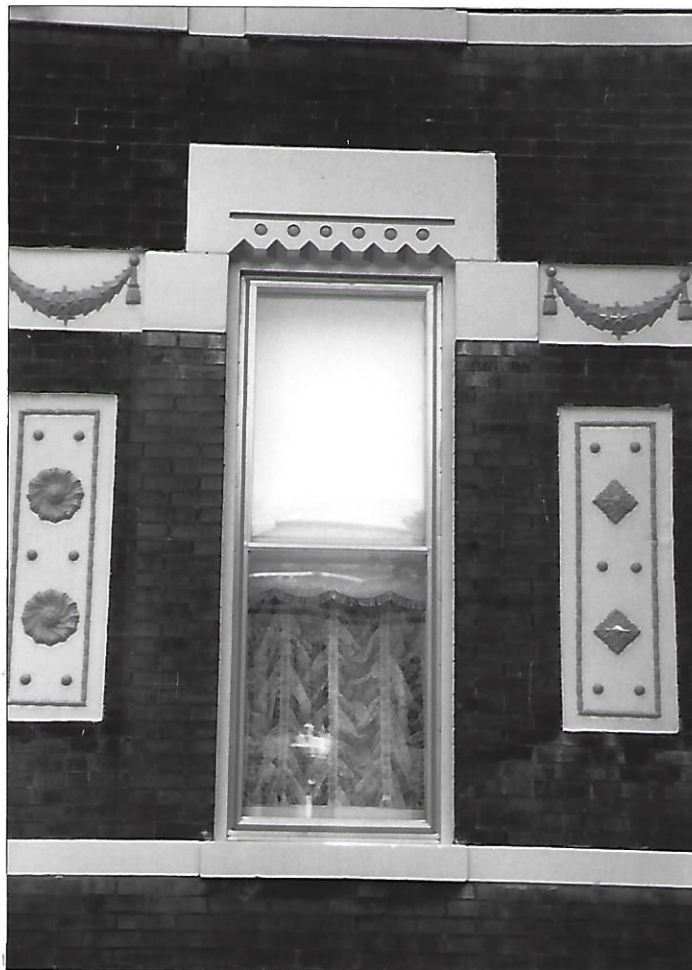
Detail of first story window on the West facade—Shows the scalloping, beading, swags, and other carvings in the stone headers and bands; also shows pressed metal panels
